INDOOR AIR QUALITY ASSESSMENT

**Berkshire Community College
Field Administration Center
1350 West Street
Pittsfield, Massachusetts**

Prepared by:
Massachusetts Department of Public Health
Bureau of Environmental Health Assessment
November 2002

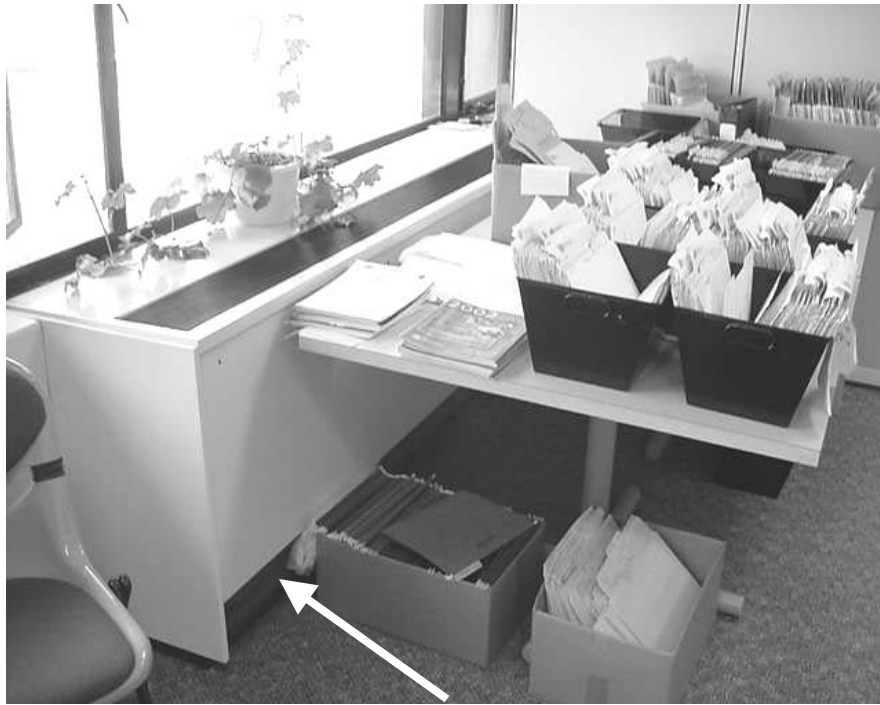
Picture 1

Fresh air in classrooms and offices with multiple occupants are equipped with a unit ventilator (univent) system (see Picture 1). Univents draw air from outdoors through a fresh air intake located on the exterior walls of the building and return air through an air intake located at the base of each unit ([see Figure 1](#)). Fresh air and return air are mixed, filtered, heated and provided to classrooms and offices through a fresh air diffuser located in the top of the unit. Desks and other items were blocking return vents in some areas. Blockage of return vents as well as holes in the floor and wall of univent cabinets

can result in increased draw of fresh air from outdoors. In order for univents to function as designed, univents must remain free of obstructions.

Univent, Note Box Blocking Return Vent and Plant Near Fresh Air Diffuser

4. Seal wall holes around telephone wires and electrical circuit breaker box.
5. Remove all blockages from univents and exhaust vents to ensure adequate airflow.

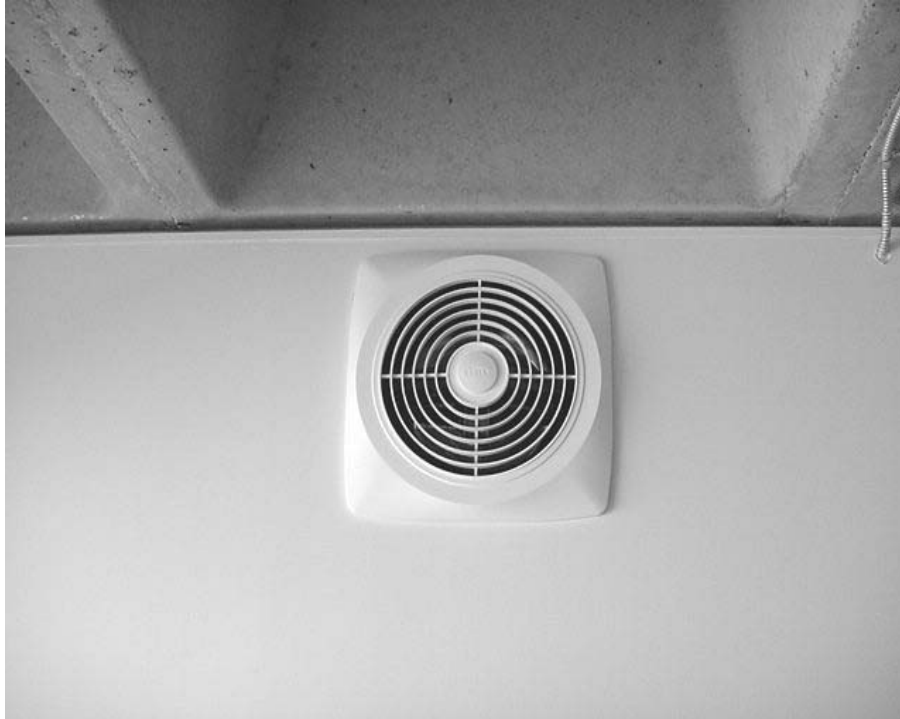
Picture 2

The building does not have a mechanical heating, ventilating and air conditioning (HVAC) system for private offices. Wall-mounted radiators provide heat in these areas. Fresh air is supplied by opening windows. In an effort to provide air movement in some offices, fans were installed in interior adjoining walls (see Picture 2). A number of areas on the second floor have been subdivided into offices and other space. Of note is the new mailbox room (see Picture 3), which has a univent that originally supplied fresh air for a large open study area. A wall was erected to form the mailroom and a corridor leading to the walkway to the KAC. A passive door vent was installed in an attempt to provide exhaust ventilation via grilles located in the wall between the second floor restrooms. This installation results in the degradation of airflow through this section of the building.

Fan Retrofitted into Adjoining Wall

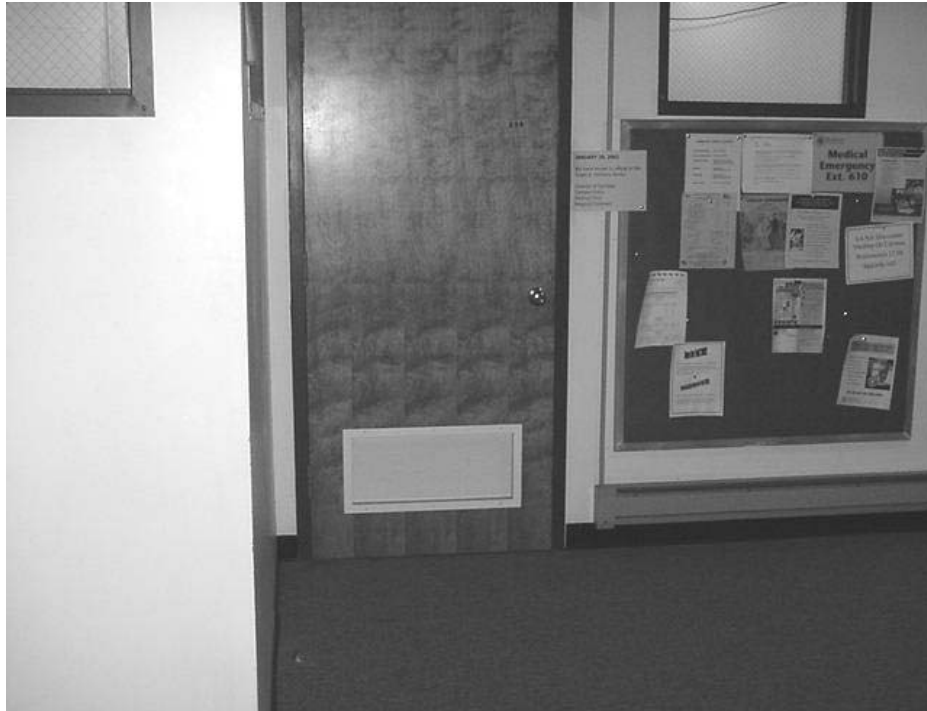
Picture 3

A significant musty odor was detected in the hallway connecting the FAC and Koussevitzky Arts Center (KAC). BEHA staff detected the odor centered around the new mailroom, previously described in the ventilation section of this assessment. College officials reported that carpeting in this area was installed several weeks prior to the BEHA visit. During the period of time that had passed between the carpet installation and date of assessment was a stretch of excessively humid weather in Massachusetts, producing an outdoor relative humidity at various times from 73 percent to 100 percent without precipitation from July 4, 2002 through July 12, 2002 (The Weather Underground, 2002). According the American Society of Heating, Refrigerating and Air-conditioning Engineers (ASHRAE), if relative humidity exceeds 70 percent, mold growth may occur due to wetting of building materials (ASHRAE, 1989).

Passive Door Vent of New Mailroom

1. Remove the carpet from the new mailbox room.
2. Consider removing the carpet from the old mailroom.
3. Seal wall and pipe floor holes associated with the heating and ventilation system, as needed.

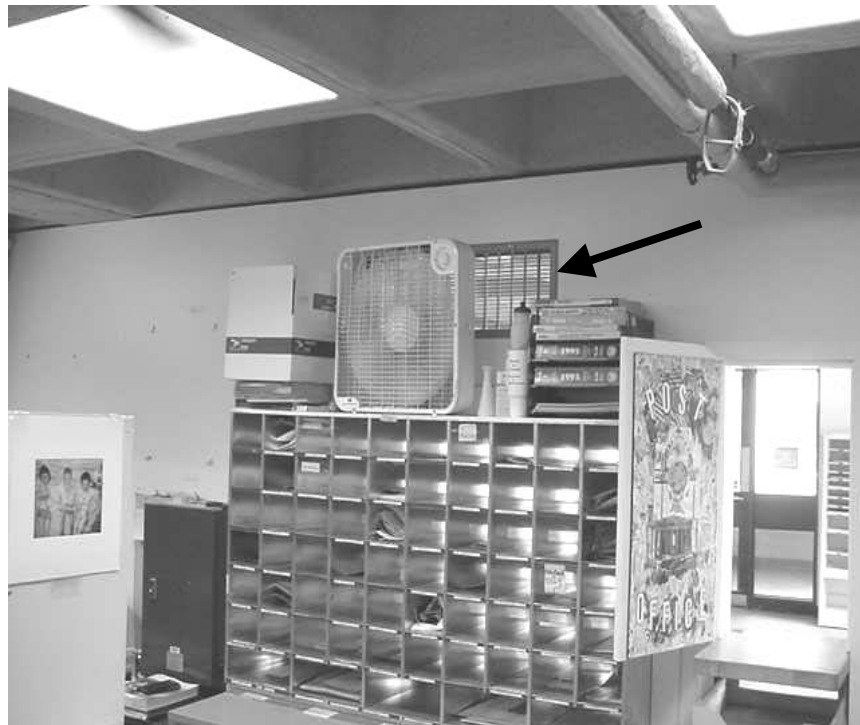
Picture 4

A similar, but less pungent odor was detected in the old mailroom during the assessment. The configuration is similar, in that walls with a passive vent were erected (see Picture 4) to create the enclosed space. However, an exhaust vent exists within this work area, with the univent operating in the foyer.

The old mailroom contains a number of electrical devices (computer, mail machine, photocopier, etc.). This room does not have a fresh air supply, but rather draws air through a passive vent (see Picture 4) from the hallway. In an effort to provide air circulation, a number of portable fans are stationed around the room. A local exhaust vent located on an interior wall was partially blocked with a plastic bag (see Picture 12). Volatile organic compounds (VOCs) and ozone can be produced by photocopiers, particularly if the equipment is older and in frequent use. Ozone is a respiratory irritant (Schmidt Etkin, D., 1992). Without proper mechanical exhaust ventilation, waste heat

Passive Vent in Old Mailroom

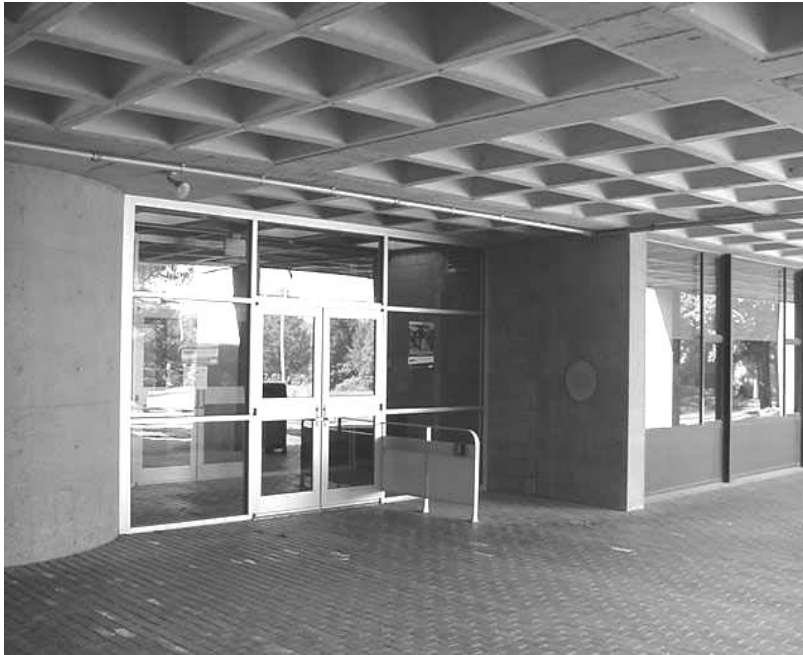
Picture 5

College officials reported that the second floor of the building experienced significant roof leaks, which were corrected with the installation of the new roof. Of interest is the condition of acoustic tile adhered to the ceiling. The ceiling system consists of a cement honeycomb design (see Picture 5). At the top of each honeycomb chamber is an acoustic ceiling tile, which seems to be directly adhered to the cement. A number of areas have tiles that appear to be water-damaged (see Picture 6). Replacement of these tiles is difficult, since their removal would likely cause the destruction of the tile, which can result in the aerosolization of particulates. Water-damaged ceiling tiles may provide a medium for mold growth and should be replaced after a water leak is discovered.

Cement Honeycomb Ceiling

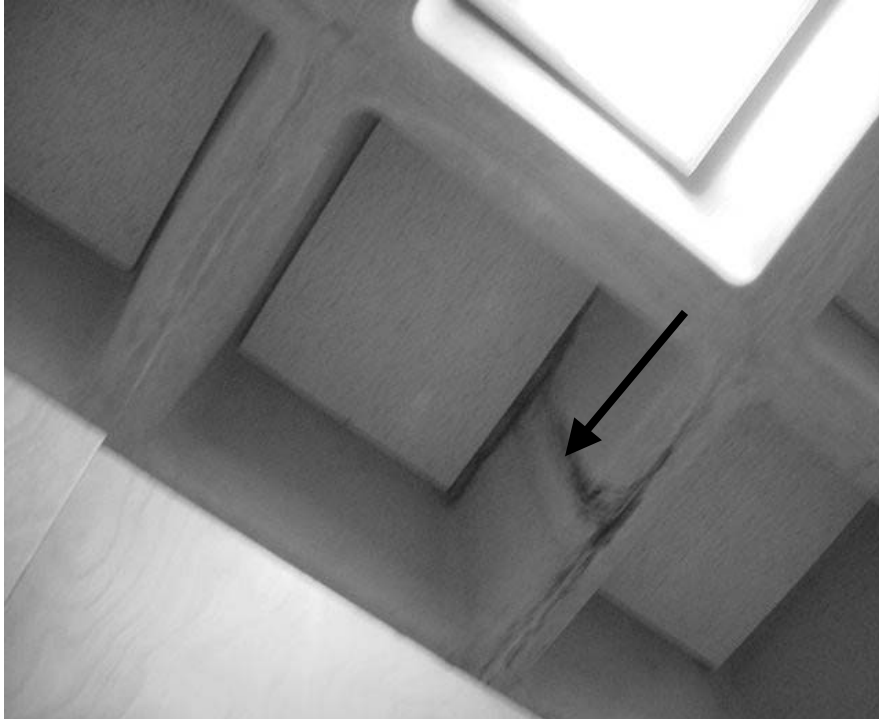
Picture 6

Honeycomb Ceiling System with Ceiling Tile Adhered To Cement, Note Water Stain

1. Water-damaged ceiling tiles should be replaced. These ceiling tiles can be a source of microbial growth and should be removed. Source of water leaks (e.g., window frames and roof) should be identified and repaired. Examine the non-porous surface beneath the removed ceiling tiles and disinfect with an appropriate antimicrobial.
2. Examine the feasibility of installing an HVAC system to service all occupied areas of the FAC.
3. Examine the feasibility of installing a sloped system to prevent snow and rain accumulation on the north-facing wall system.
4. Consider installing an exhaust vent fan on one of the openings to the crawlspace to depressurize this area and prevent/limit air movement to occupied areas.

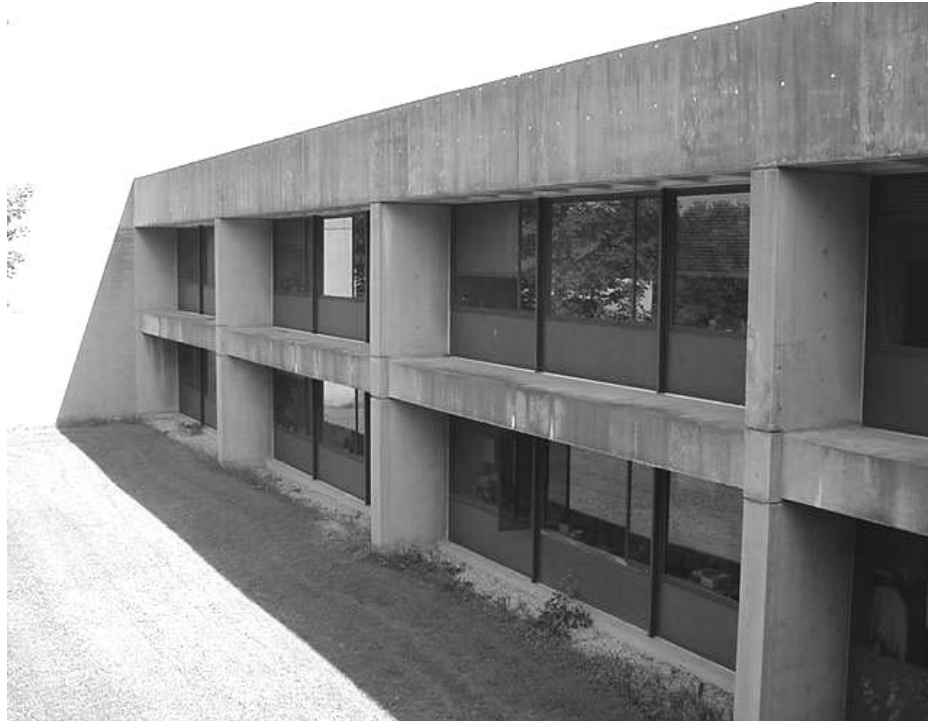
Picture 7

Of note is the design of the building. Offices along the northern face of the FAC were built on a cement slab that extends several feet horizontally from the window system to form a ledge (see Picture 7). The exterior wall on each slab is formed by a combination metal frame/spandrel/glass window/wall system. The seams between the wall system and cement slab appear to be sealed with new caulking (possibly during the

installation of new roof). This design allows rainwater and snow to collect on the horizontal surface and pool/drift against the exterior wall. This may have resulted in water penetration into the interior of offices through fissures and cracks in exterior walls. Some seams in caulking were observed which can serve as pathways for water penetration into the wall system. In addition, seams within the metal frame/spandrel/glass window/wall system were not sealed. If spaces exist in this wall system, water may penetrate into the interior.

Ledges on The North side of The FAC

9. Examine the sealant in the window system on the north facing walls. Repair missing or damaged sealant as needed.
10. Remove the door to the mailbox room to improve air circulation in this area.

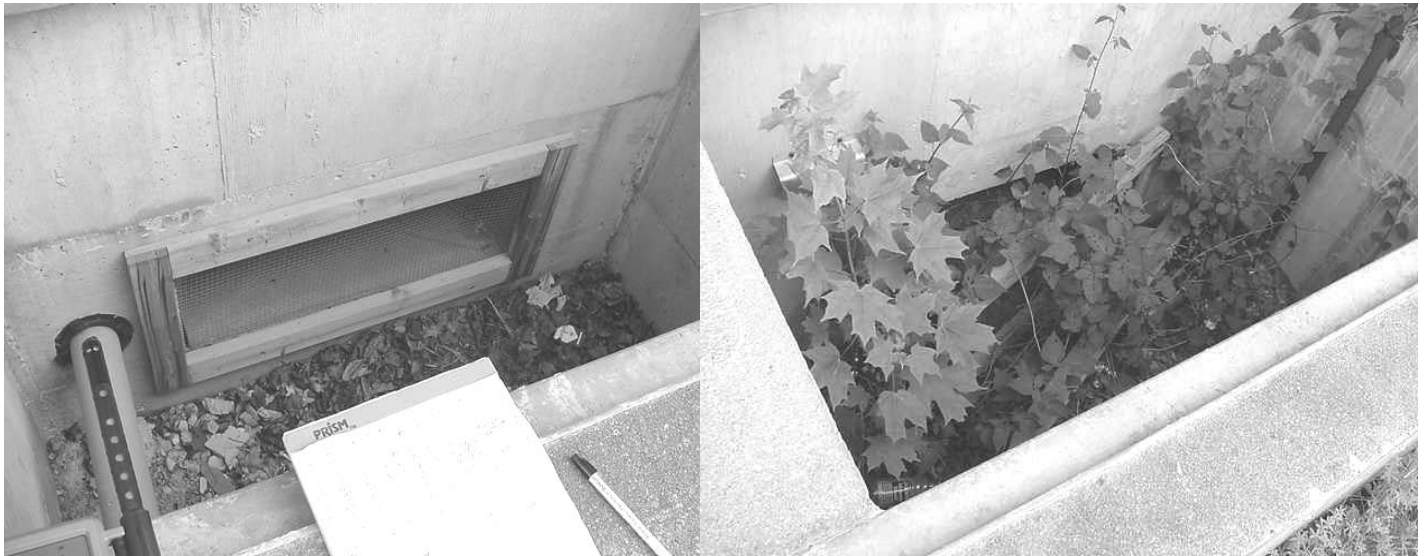
Pictures 8 and 8A

A crawlspace exists beneath the first floor, with an opening along the north wall (see Pictures 8 and 8A). Several openings to the crawl space on the first floor may exist, which would include heating pipes for univents and radiators; electrical circuit breaker box wire holes (see Pictures 9 and 9A); and the telephone service box (see Pictures 10 and 10A). Each of these can provide pathways for crawlspace air to penetrate into occupied areas. In order to explain how crawlspace pollutants may be impacting above

The crawlspace openings are located on the northern wall, which are open to the outdoors (see Picture 9). As winds strike the building, the receded wall system can act in a manner to direct cold air into the crawlspace pressurizing this area. Transfer of air from the crawlspace and wall interiors into occupied areas should be prevented.

Outdoor Openings to Crawlspace

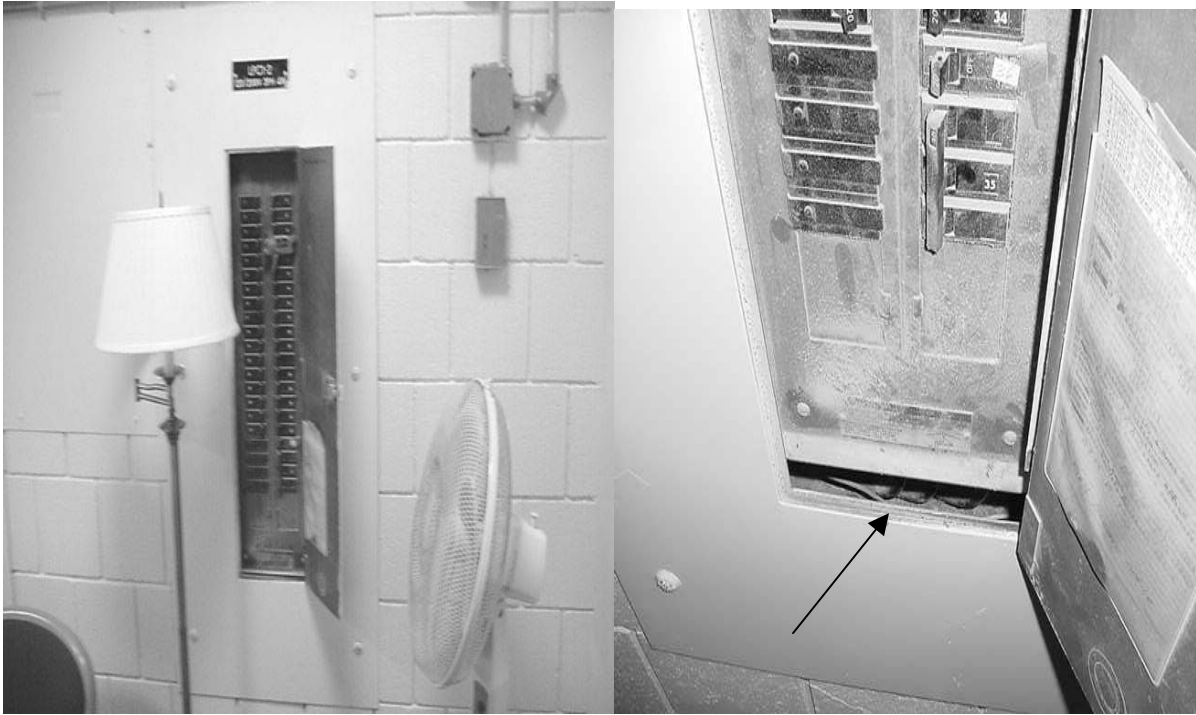
Picture 9 and 9A

The Circuit Breaker Box, Note Dust and Holes in Is Base

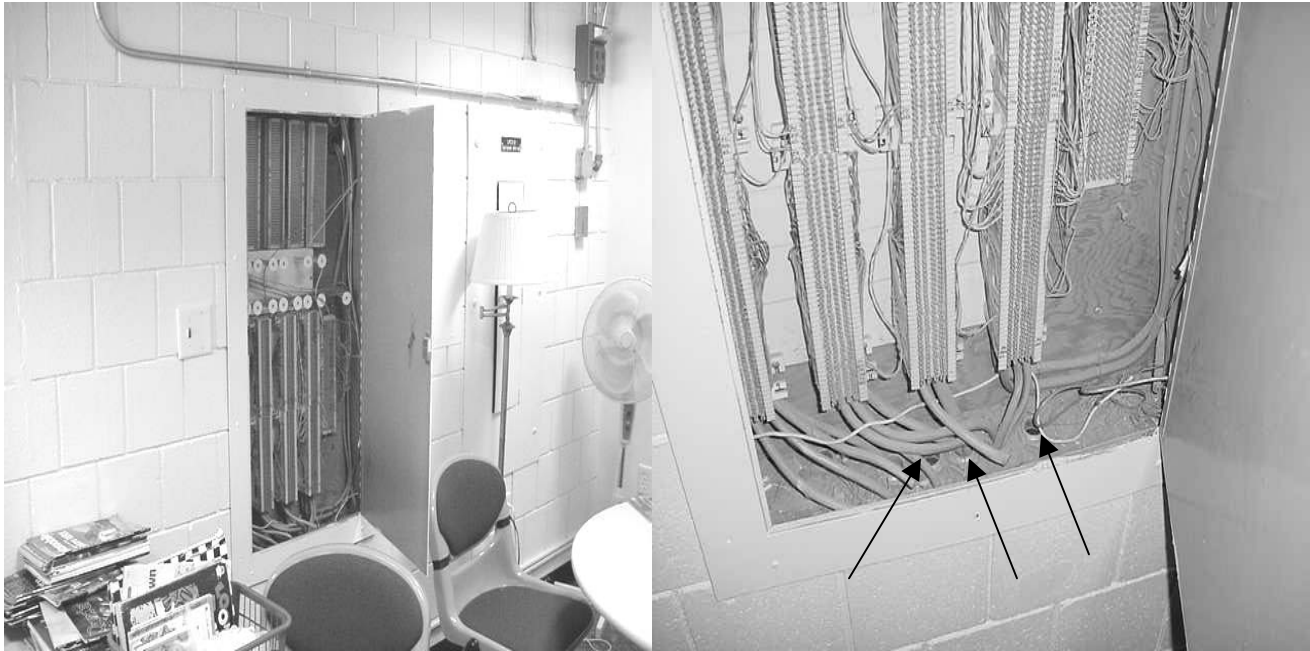
Pictures 10 and 10A

The Telephone Service Box, Note Hole In Its Base

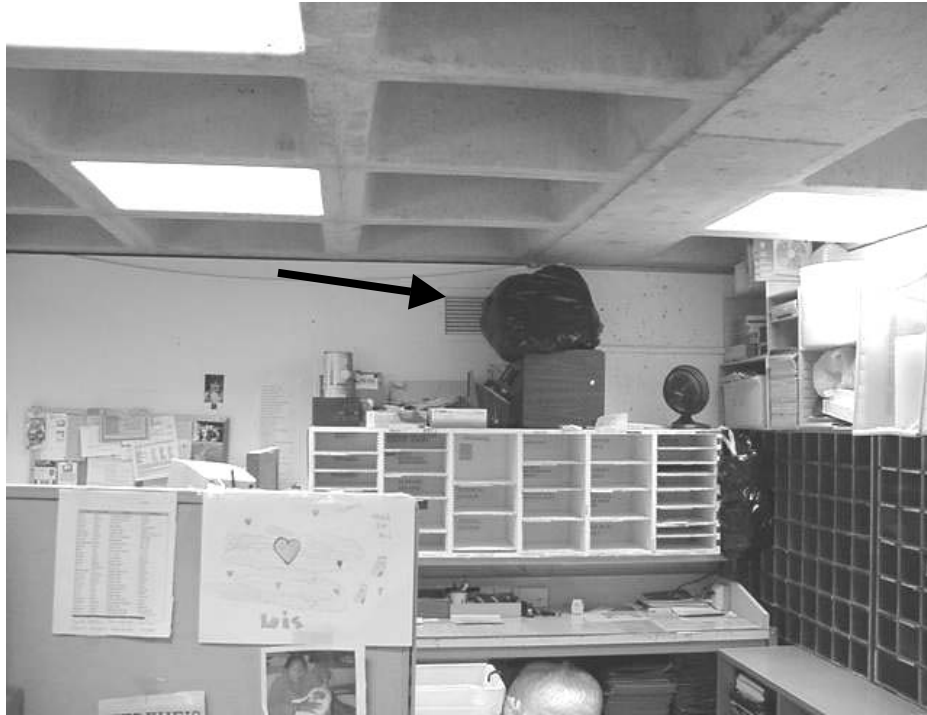
Picture 11

The mechanical exhaust ventilation system consists of ceiling and wall-mounted exhaust vents. These vents are connected to exhaust fans on the roof. Exhaust vents were drawing weakly in some areas.

Exhaust Vent Partially Blocked by Plastic Bag In Mailroom

8. Examine exhaust ventilation for function. Improve air draw of exhaust vents on the second floor. Repair motors if necessary and operate exhaust system during occupancy.
